EFM8 Busy Bee

EFM8BB3 Errata

This document contains information on the EFM8BB3 errata. The latest available revision of this device is revision D.

Errata effective date: November, 2020.

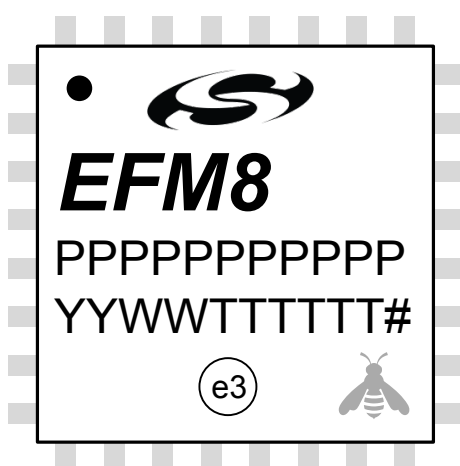
Correct QFP32
Package Marking

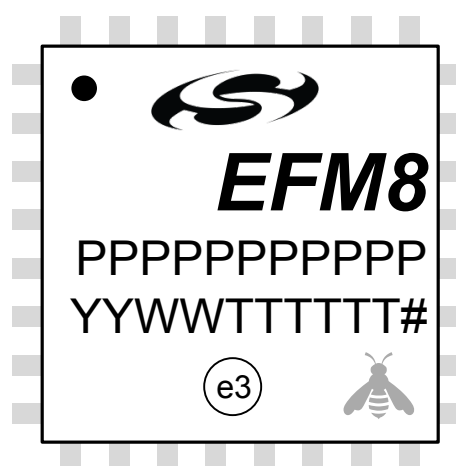
The Package Marking diagrams indicate that the package marking is left justified. However, QFP32 devices with the 1531 date code have package markings that are right justified.

Incorrect QFP32
Package Marking

Assembly houses expecting left-justified package marking may see some parts with right-justified package marking.

There is currently no workaround for this issue.

This issue only affects revision A QFP32 devices with a date code of 1531. All other devices should match the Package Marking diagrams in the device data sheet.
