EFM8 Laser Bee EFM8LB1 Errata

This document contains information on the EFM8LB1 errata. The latest available revision of this device is revision C. Note that revision C devices omit the crystal oscillator. Applications requiring a crystal should specify a revision B part number.

Errata effective date: November, 2022.

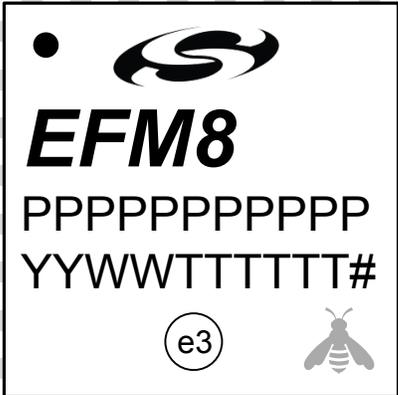
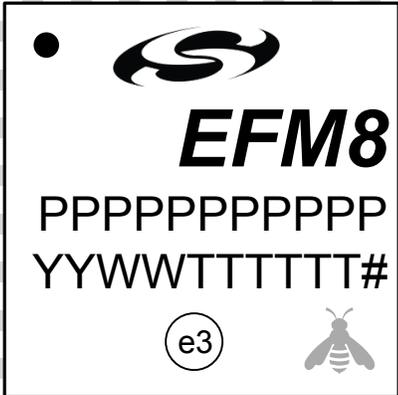
Description of Errata	
<p>The Package Marking diagrams indicate that the package marking is left justified. However, QFP32 devices with the 1531 date code have package markings that are right justified.</p>

<p>Correct QFP32 Package Marking</p>	<p>Incorrect QFP32 Package Marking</p>
Affected Conditions / Impacts	
<p>Assembly houses expecting left-justified package marking may see some parts with right-justified package marking.</p>	
Workaround	
<p>There is currently no workaround for this issue.</p>	
Resolution	
<p>This issue only affects revision A QFP32 devices with a date code of 1531. All other devices should match the Package Marking diagrams in the device data sheet.</p>
