EFM8 Universal Bee

EFM8UB1 Errata

Errata effective date: May, 2019.

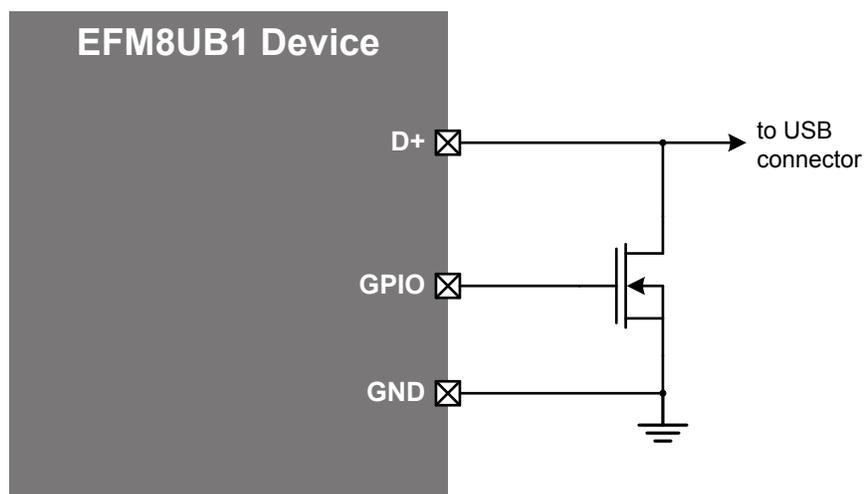
During and immediately following power-on reset, the USB D+ and D- pins are undefined. These pins can be logic high, logic low, or mid-supply. This behavior typically lasts for ~15 ms, at which point the D+ and D- pins operate normally. The USB specification provides a 100 ms settling/debounce period after power-on.

Some USB host devices may require the USB D+ and D- pins be in a known state during or immediately following power-on reset to start properly.

Adding an external circuit to the USB D+ and D- pins can force the desired state on these pins during and immediately following power-on reset. The rising edge of RSTb signals the end of power-on reset.

An example circuit is shown below:

This circuit uses an NMOS transistor and a GPIO pin to short D+ to ground during power-on. The GPIO pin will be open drain and pulled high through a weak pull-up during reset. When the GPIO is driven low soon after the device exits reset, D+ is no longer shorted to ground, enabling normal USB enumeration to occur.
