SiWG917 – TA Flash Memory Map Change Guide

Version 1.3

1 Introduction

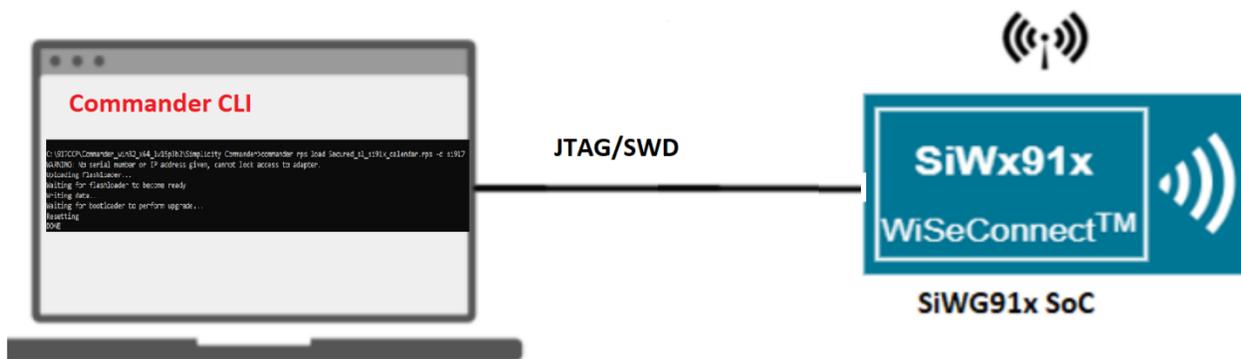
Users must adapt the change based on the results from [MBR version check](#). If 'MBR version check' returns 1F, then no change to MBR is needed. In this case, users can directly make project-related changes per section [Configuring the M4](#). In case the MBR value is 1B, the user needs to use Simplicity Commander CLI and update the MBR per the following section starting from Simplicity Commander CLI.

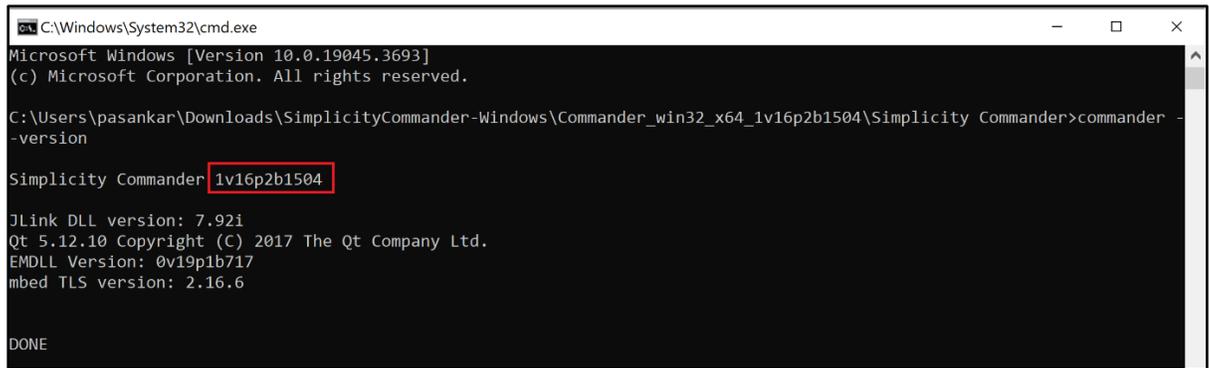
Note : To check commander version open the cli mode (To open commander cli mode follow [Section 3.1](#) from [step 1](#) to [step 3](#)) and give the following command :

commander -version

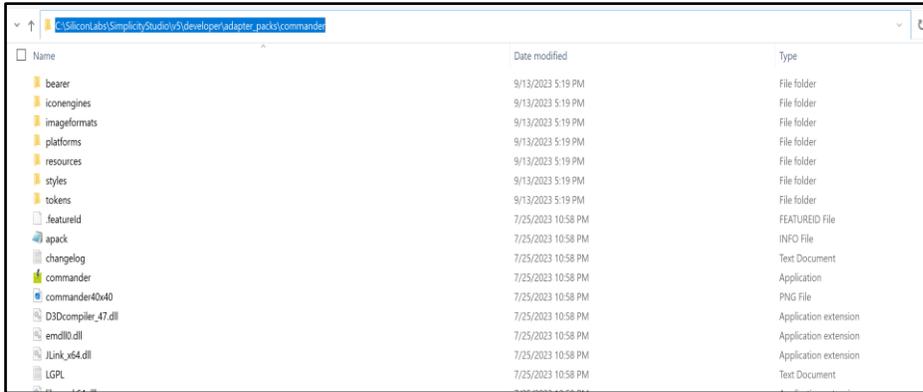
1. Connect the device to the PC using USB cable (type C).
2. Traverse to the path where Simplicity Studio is installed
For our case the path (default path) is : **C:\SiliconLabs\SimplicityStudio\v5\developer\adapter_packs\commander**

3. Type “cmd” in highlighted part section in the above picture and hit enter. It will open the command prompt CLI in that path.
